Technical Inspection Report

Company	Alara Wholefoods Limited
Address	110-112 Camley Street, Kings Cross, London. N1C 4PF
Report Reference	RE13688
Inspection Date	05 February 2018
Inspected By	Dave Limb - Technical Officer
For the attention of	Omowunmi Olunloyo (toks@alara.co.uk) & (technical.manager@alara.co.uk)

RE13688

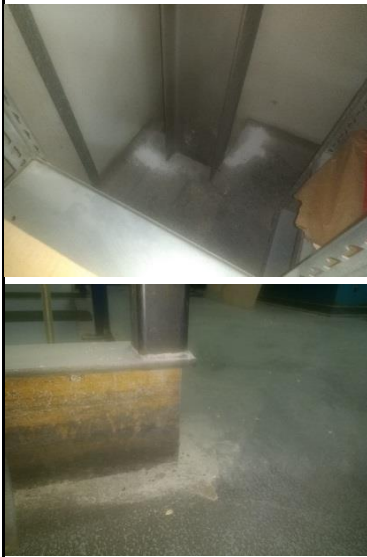
Ref	Location	Issues	Defects	Priority	Observations and Recommendations	Photo	Action By	Action Taken & Date Complete	Status
6	Unit 2, Mezzanine	M	H	Medium	There has been an issue with mouse activity in this area recently. On inspection, several mouse droppings were noted on the floor in the corner behind racking. Droppings were also noted behind pallets, along the wall between the racking and the stairs in the far corner. In the far corner by the stairs, droppings and footprints in tracking powder were noted. Droppings were also noted by the fall rail near the compactor. Recommend all the droppings are cleared.

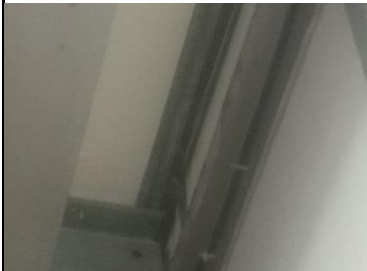
Check, Hygiene		Open
7	Unit 2, Mezzanine	M	P	Medium	I was informed that staff recently saw a mouse fall from the gap between the top of the wall and in a gap that runs along the join. It is not possible to inspect this further without access equipment and maybe the removal of a panel, to inspect for signs of activity. Ideally we could access this area to bait it but ultimately, I would suggest the gap is sealed.

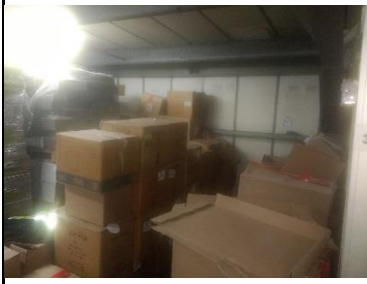
Ref	Location	Issues	Defects	Priority	Observations and Recommendations	Photo	Action By	Action Taken & Date Complete	Status
8	Unit 2, Mezzanine		S	Low	Wall stacking in this area hampered inspection.

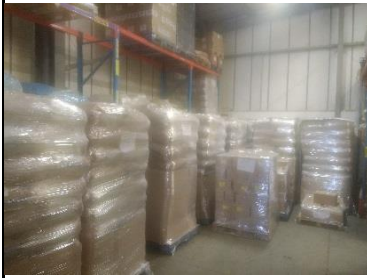
Site		Open
9	Unit 2, Packing Area, Ground Floor				No evidence of any rodent activity. No SPI activity noted in the packing machines.				
10	Unit 2, Warehouse		S	Low	Congestion hampered inspection.

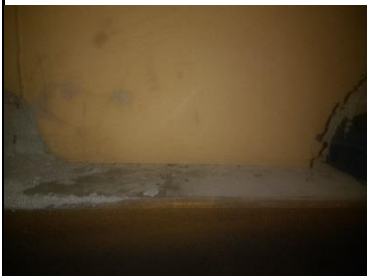
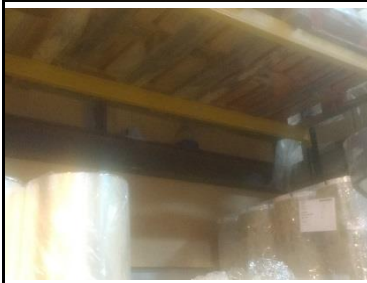
Ref	Location	Issues	Defects	Priority	Observations and Recommendations	Photo	Action By	Action Taken & Date Complete	Status
11	Unit 2, Warehouse		H	Low	No rodent activity was noted at ground level but there has recently been evidence of mice on a ledge behind racking, to the right of the compactor. Traps have been placed here. They were checked and found clear. Droppings on the ledge (reported at the time) need to be cleared.

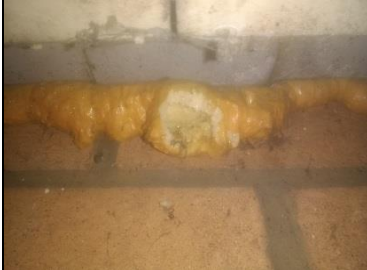
Ref	Location	Issues	Defects	Priority	Observations and Recommendations	Photo	Action By	Action Taken & Date Complete	Status
13	External				<p>Where the brickwork meets the metal cladding on the side of the building (at approximately 6' high), there was a gap between the two that was sealed with foam a long time ago. Today I noticed that the foam has been damaged in several areas. Nowhere did I see that the foam had been penetrated, giving access to the wall cavity. This does, however, clearly show that rodents are making their way up the wall and attempting to enter via this point.</p> <p>I cannot say for sure which rodent has caused this but this particular picture does suggest Rat.</p>

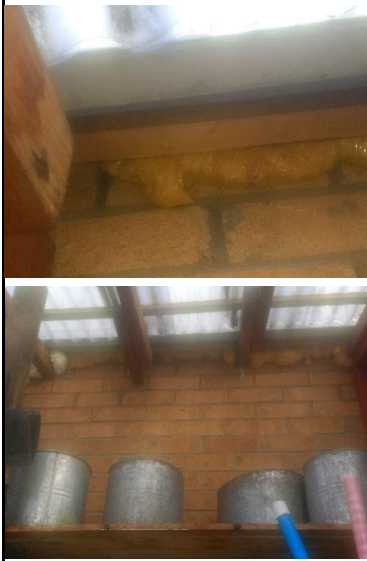
Ref	Location	Issues	Defects	Priority	Observations and Recommendations	Photo	Action By	Action Taken & Date Complete	Status
14	External				<p>At the front of the building, just to the right of the pedestrian door, there is a storage area. The gap above this was once an ingress point for rodents, until it was sealed. Recently the sealant had been gnawed although no rodents had accessed the void above the offices. This has now been resolved and the gap resealed. Whilst it is difficult to access to be certain, there may be gaps above the wooden baton used to keep the roof on. Foam has been used beneath it but there is a gap above it, on the right hand side, that may possibly provide access. Ideally this gap should also be sealed, if only as a precaution.</p>

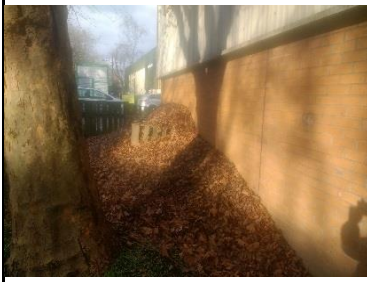
Site		Open
15	External				<p>A large collection of leaves was found against the rear of Unit 1. We would normally suggest this is stored elsewhere as it could provide harbourage and a breeding area for rodents.</p>
